CABLE CUT

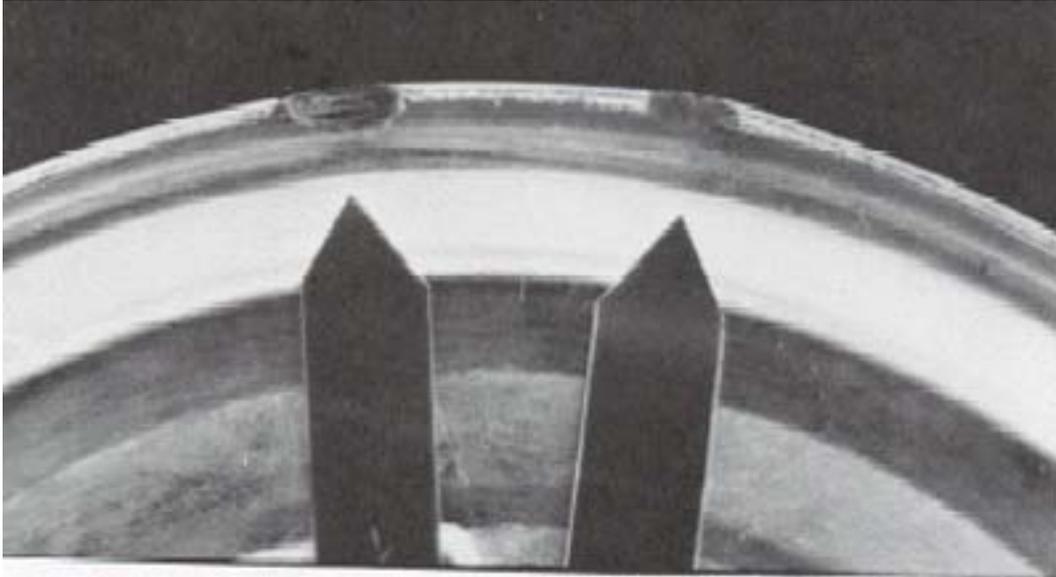
Table IV, left pointer, Defect No. 114, Major defect - Exposed seam laminations. Right pointer, Insignificant Defect. Seam laminations not exposed by slight cable cut.
